# BEYOND THE WALLS

Extending ICRA Outside and Underground for a Multi-Building Hospital Campus Construction Project

**BEYOND THE WALLS:  
EXTENDING ICRA OUTSIDE AND UNDERGROUND FOR A MULTI-BUILDING  
HOSPITAL CAMPUS CONSTRUCTION PROJECT**

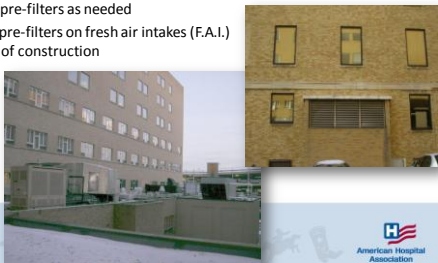
- Sealing locked/screwed shut exterior windows with silicone on critically exposed building facades
- Inspecting & correcting air-handling unit pre-filter assemblies for tightness
- Changing pre-filters as needed
- Installing pre-filters on fresh air intakes (F.A.I.) in vicinity of construction

- Installation of a ductwork extension on the fresh air intake of the heating, ventilation and air condition (HVAC systems) serving areas of concern;
- The implementation of Contractor work practices and cleaning activities during renovation and construction operations to reduce the spread of dust and construction-related contaminants to other areas of the Hospital;
